# **Pentium® II Processor Specification Update**

Release Date: April 8, 1998

Order Number: 243337-013

The Pentium® II processor may contain design defects or errors known as errata which may cause the product to deviate from published specifications. Current characterized errata are documented in this Specification Update.

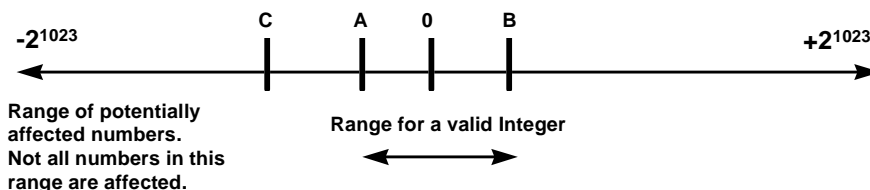
Discrete failing operands will be present in the range between point C and the maximum negative number that can be represented by the processor ( $-2^{1023}$  in double precision format). Note 2 below gives a qualitative description of the nature of the discrete failing values. Software that does not rely on the Invalid Operation exception flag being set and signaled by either an exception OR by software polling is not impacted by this erratum.

16-bit Operation	A	B	C
	-32,768.0	+32,767.0	< -98304.0
32-bit Operation	A	B	C
	-2,147,483,648.0	+2,147,483,647.0	< -6,442,450,944.0

**WORKAROUND:** Any of two software workarounds will avoid occurrence of this erratum:

1. Range checking performed prior to execution of the FIST[P] instruction will prevent the overflow condition from occurring, and may already be implemented as a standard coding style.

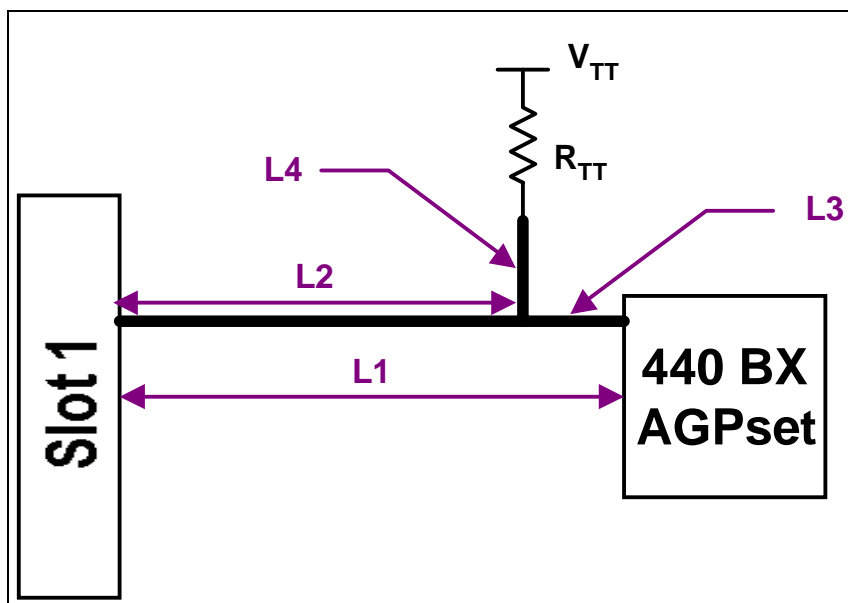
Figure 1. UP Dual Ended Termination (DET)

For UP-DET topologies (Figure 1), the trace length L1 must be between 1.5" to 4.5" while using a 56 ohm termination resistor.

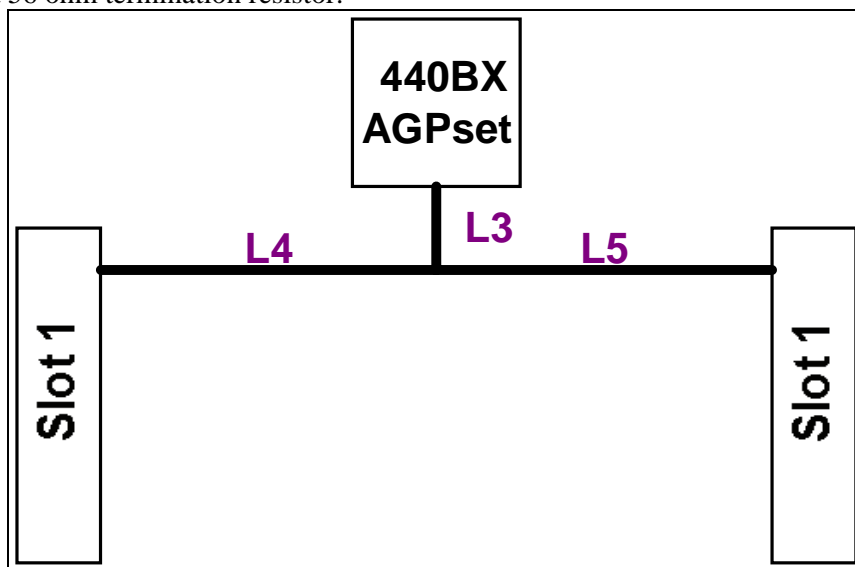
Figure 2. DP Dual Ended Termination (DET)

For DP topologies (Figure 2) installed with a processor and a terminator card, on one of the legs, L3+L4 or L3+L5 must be  $\leq 4.5$  and the leg that is  $> 4.5$ " must have the terminator card.
